Use Attainability Analysis
for

WBID 1351 Horse Creek

SES, Inc.

Field Data Sheets for Recreation Use Stream Surveys
Data Sheet A - Water Body Identification
(For water body being surveyed)

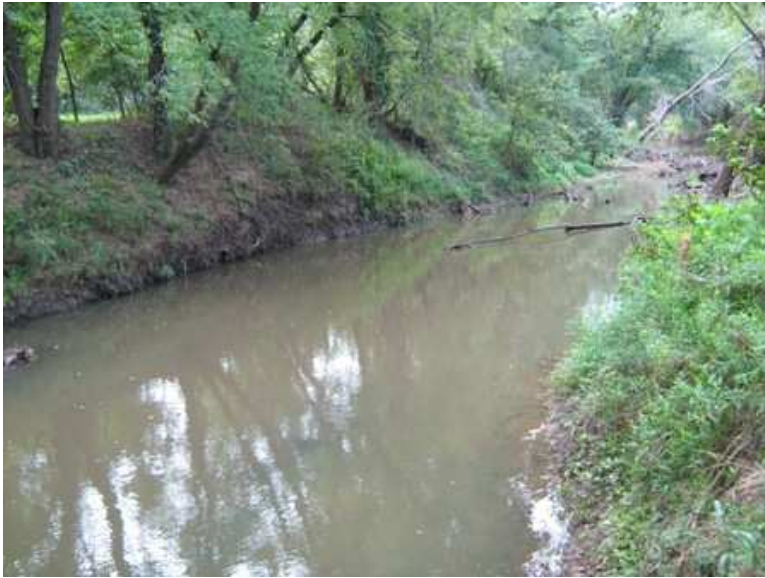
Site# 1 Photo ID# 2, Upstream

WBID # 1351 **Site #** 1
Mark # 61 **Dissolved Oxygen (ppm)** 5.2
Upstream Views Physical Dimensions: Is there any water present at this view? y
 If so, is there an obvious current? y

% of Channel Feature				
Riffle					
Run	45				
Pool	55

% Cobble	% Gravel	50% Sand	50% Silt
% Mud/Clay	% Bedrock

Broadleaf arrowhead at one transect.

Odor	Sewage	<u>Musky</u>	Chemical	None	Other
Color	Clear	Green	Gray	<u>Milky</u>	<u>Other</u> <u>brown</u>
Bottom Deposit	Sludge	Solids	Fine Sed.	<u>None</u>	Other
Surface Deposit	Oil	Scum	Foam	<u>None</u>	Other

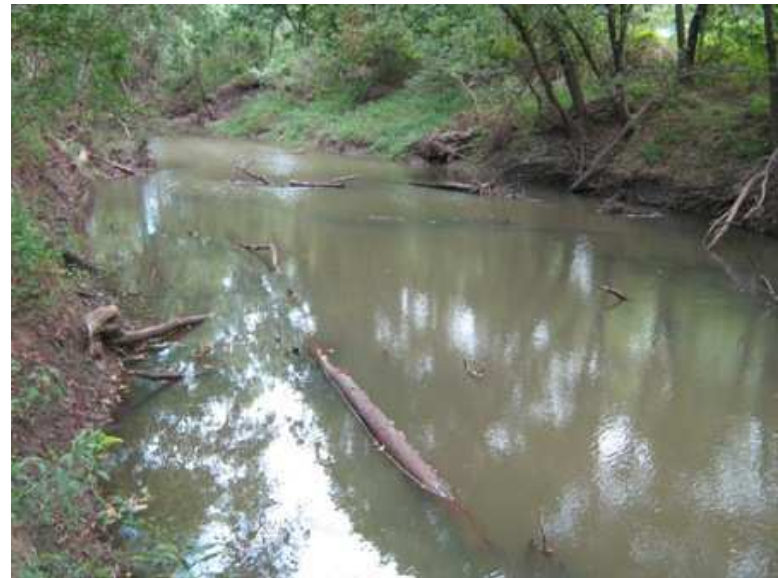
Site# 1 Photo ID# 1, Downstream

Downstream View's Physical Dimensions: Is there any water present at this view? y
 If so, is there an obvious current? y

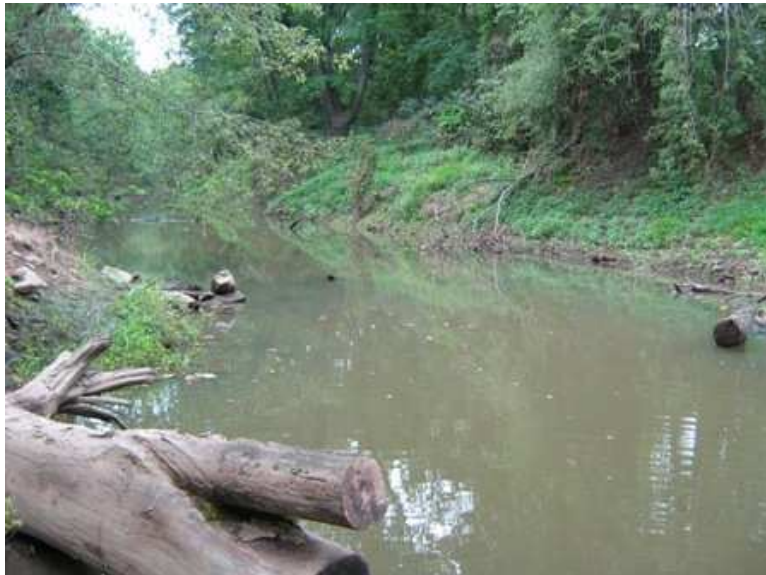
Site# 2 Photo ID# 3, Upstream

WBID # 1351 **Site #** 2
Mark # 62 **Dissolved Oxygen (ppm)** 4.8
Upstream Views Physical Dimensions: Is there any water present at this view? y
 If so, is there an obvious current? n

% of Channel Feature				
Riffle					
Run					
Pool	100

% Cobble	% Gravel	50% Sand	50% Silt
% Mud/Clay	% Bedrock

none

Odor	Sewage	<u>Musky</u>	Chemical	None	Other
Color	Clear	Green	Gray	<u>Milky</u>	<u>Other</u> <u>brown</u>
Bottom Deposit	Sludge	Solids	Fine Sed.	<u>None</u>	Other
Surface Deposit	Oil	Scum	Foam	<u>None</u>	Other

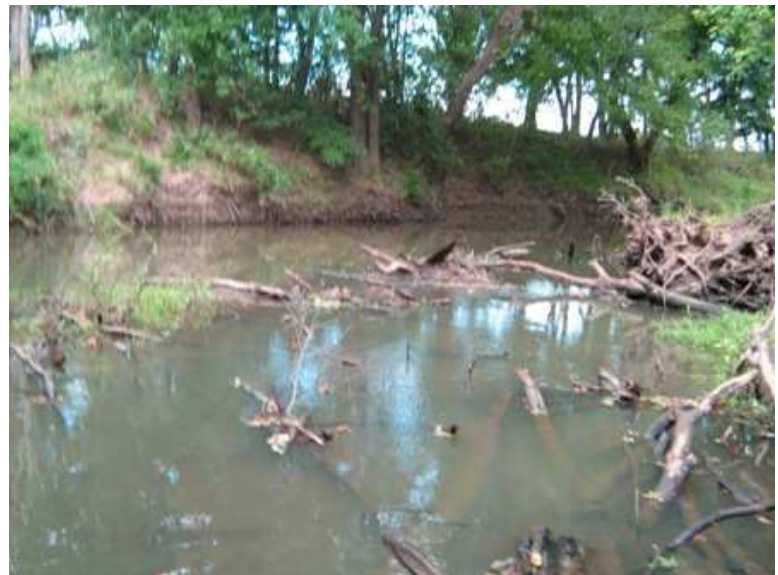
Site# 2 Photo ID# 4, Downstream

Downstream View's Physical Dimensions: Is there any water present at this view? y
 If so, is there an obvious current? n

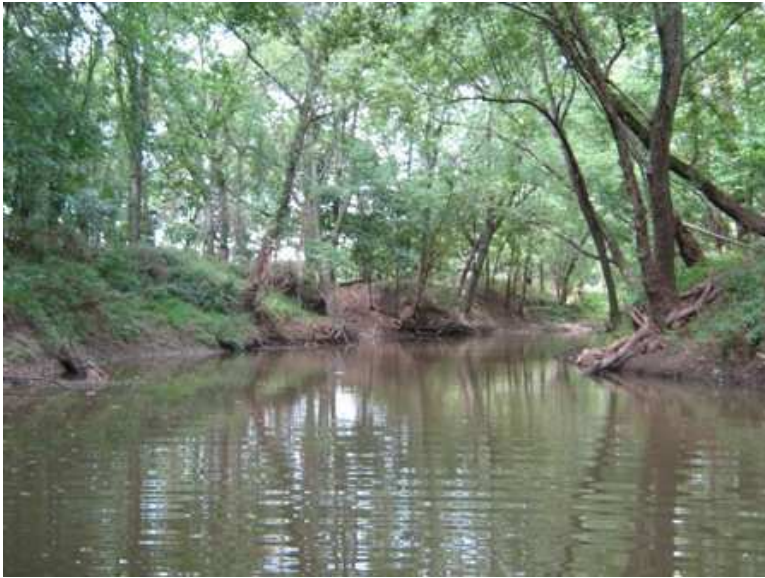
Site# 3 Photo ID# 7, Upstream

WBID # 1351 **Site #** 3
Mark # 63 **Dissolved Oxygen (ppm)** 3.3
Upstream Views Physical Dimensions: Is there any water present at this view? y
 If so, is there an obvious current? n

% of Channel Feature				
Riffle					
Run	100				
Pool

% Cobble	% Gravel	% Sand	50% Silt
50% Mud/Clay	% Bedrock

Odor	Sewage	Musky	Chemical	<u>None</u>	Other
Color	Clear	Green	Gray	<u>Milky</u>	<u>Other</u> <u>Brown</u>
Bottom Deposit	Sludge	Solids	Fine Sed.	<u>None</u>	Other
Surface Deposit	Oil	Scum	Foam	<u>None</u>	Other

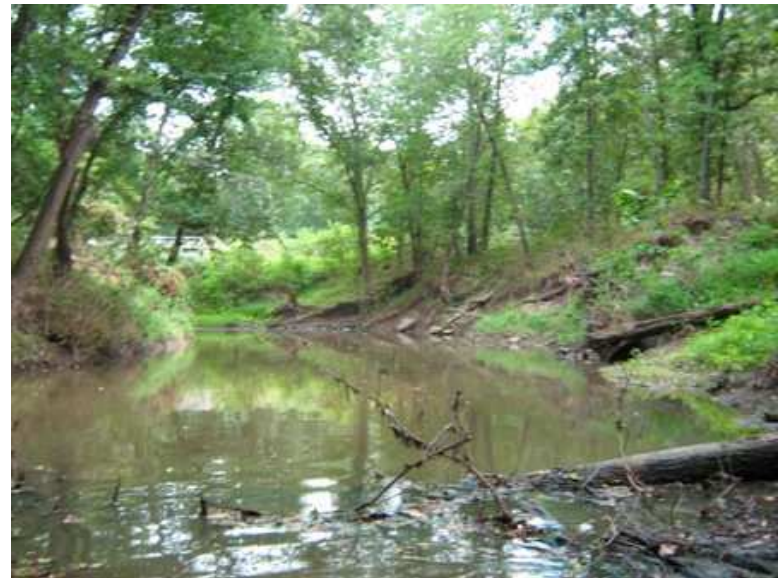
Site# 3 Photo ID# 6, Downstream

Downstream View's Physical Dimensions: Is there any water present at this view? y
 If so, is there an obvious current? n

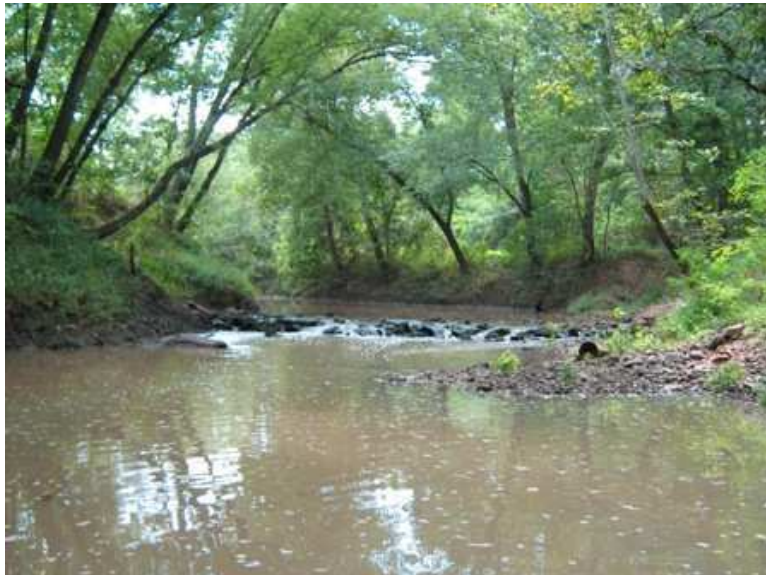
Site# 4 Photo ID# 9, Upstream

WBID # 1351 **Site #** 4
Mark # 64 **Dissolved Oxygen (ppm)** 3.5
Upstream Views Physical Dimensions: Is there any water present at this view? y
 If so, is there an obvious current? y

% of Channel Feature				
Riffle	9				
Run	64				
Pool	27

5% Cobble	% Gravel	% Sand	95% Silt
% Mud/Clay	% Bedrock

small willow in 70% of the channel at transect 6

Odor	Sewage	Musky	Chemical	<u>None</u>	Other
Color	Clear	Green	Gray	<u>Milky</u>	<u>Other</u> <u>brown</u>
Bottom Deposit	Sludge	Solids	Fine Sed.	<u>None</u>	Other
Surface Deposit	Oil	Scum	Foam	<u>None</u>	Other

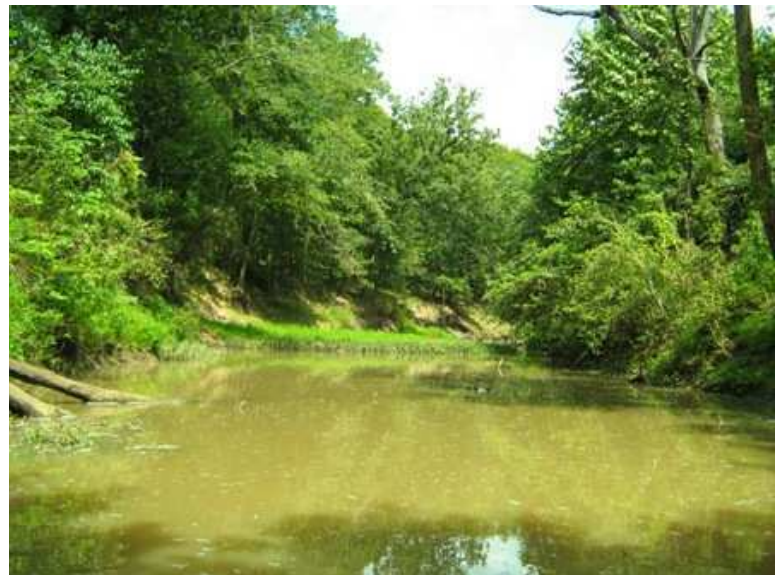
Site# 4 Photo ID# 8, Downstream

Downstream View's Physical Dimensions: Is there any water present at this view? y
 If so, is there an obvious current? n

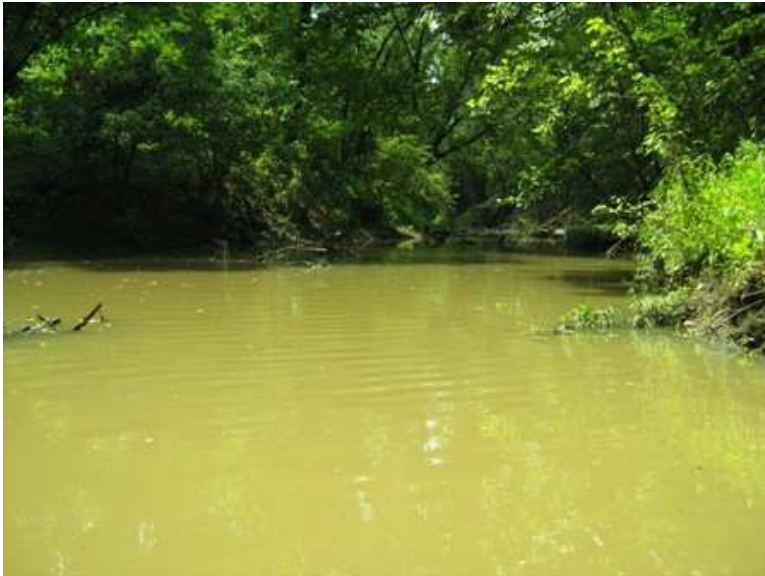
Site# 5 Photo ID# 10, Upstream

Odor	Sewage	Musky	Chemical	<u>None</u>	Other	
Color	Clear	Green	Gray	<u>Milky</u>	<u>Other</u>	<u>brown</u>
Bottom Deposit	Sludge	Solids	Fine Sed.	<u>None</u>	Other	
Surface Deposit	Oil	Scum	Foam	<u>None</u>	Other

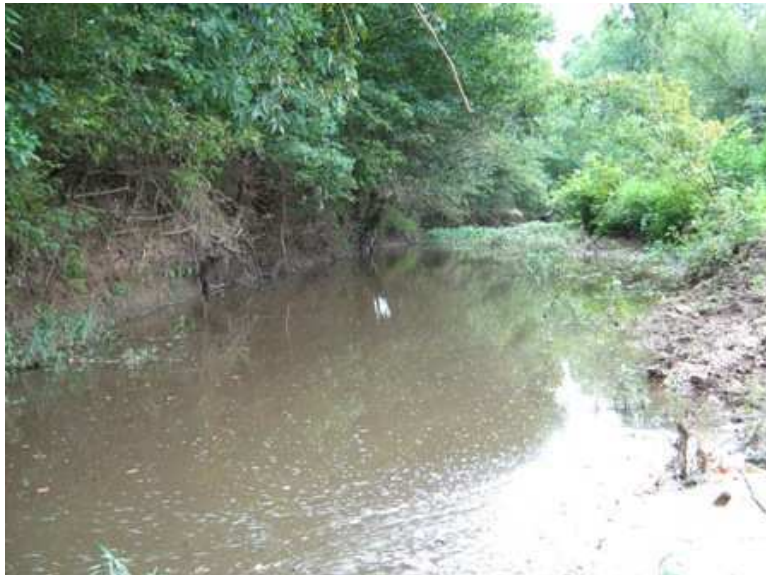
Site# 6 Photo ID# 13, Upstream

WBID # 1351 **Site #** 6
Mark # 66 **Dissolved Oxygen (ppm)** 3.2
Upstream Views Physical Dimensions: Is there any water present at this view? y
 If so, is there an obvious current? n

% of Channel Feature				
Riffle	18				
Run	37				
Pool	45

18% Cobble	27% Gravel	10% Sand	45% Silt
% Mud/Clay	% Bedrock

20% willow at 3 transects

Odor	Sewage	Musky	Chemical	<u>None</u>	Other
Color	Clear	Green	Gray	<u>Milky</u>	<u>Other</u> <u>brown</u>
Bottom Deposit	Sludge	Solids	Fine Sed.	<u>None</u>	Other
Surface Deposit	Oil	Scum	<u>Foam</u>	None	Other

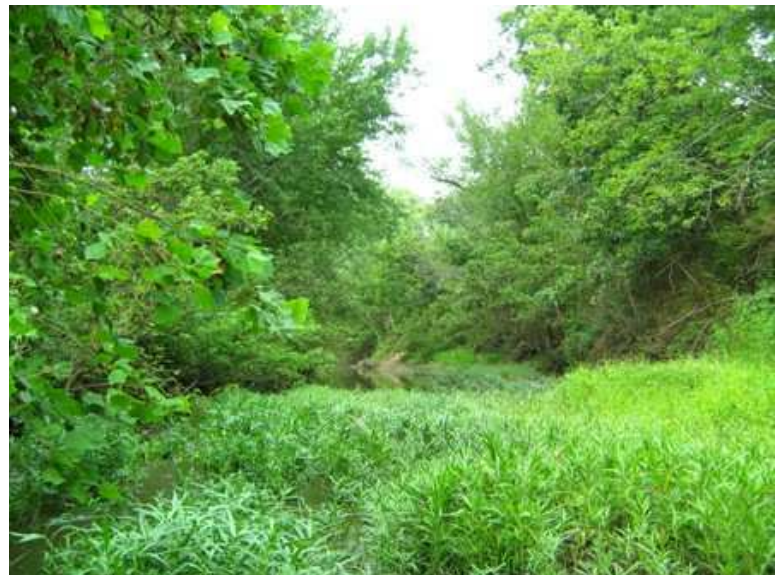
Site# 6 Photo ID# 12, Downstream

Downstream View's Physical Dimensions: Is there any water present at this view? y
 If so, is there an obvious current? y
